Vol. 18 No. 2

THE SEALING TECHNOLOGY MAGAZINE

How collaboration and experimentation
whipped a slurry

Chemical plant quenches vibrations in its cooling tower

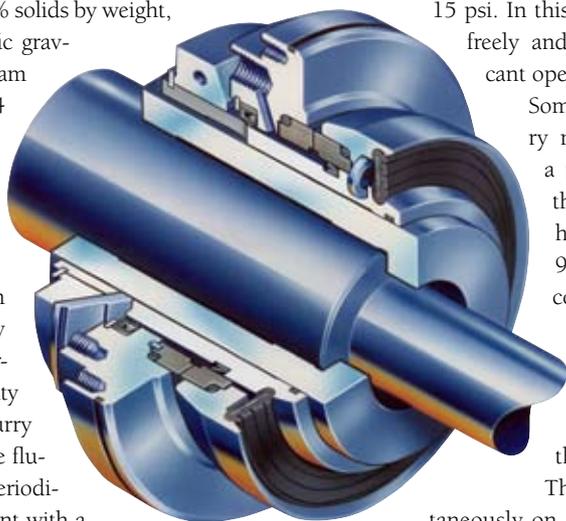
Flowserve suggested using a SLC Group 1 single balanced cartridge seal designed for tough slurries. It features a non-clogging cone spring design that increases seal reliability. The addition of a lip seal permitted Thermphos to install a Plan 32 water quench system to flush the seal's external surface and prevent crystallization. The scheme was facilitated by the drain from the water-cooled bearings on an adjacent mill, which could be rerouted to provide the recommended water flow of 2 lpm at 0.2 bar to the proposed seal arrangement.

The idea worked and the pump and seal are still running trouble-free after a year. The only leak now is clean water coming past the lip seal. "I want to see the interior of the pump when we finally take it out of service," said Ostojitsch. "I think there will be nothing left of the insides. The seal will probably be the only thing left. We're more than pleased with the outcome."

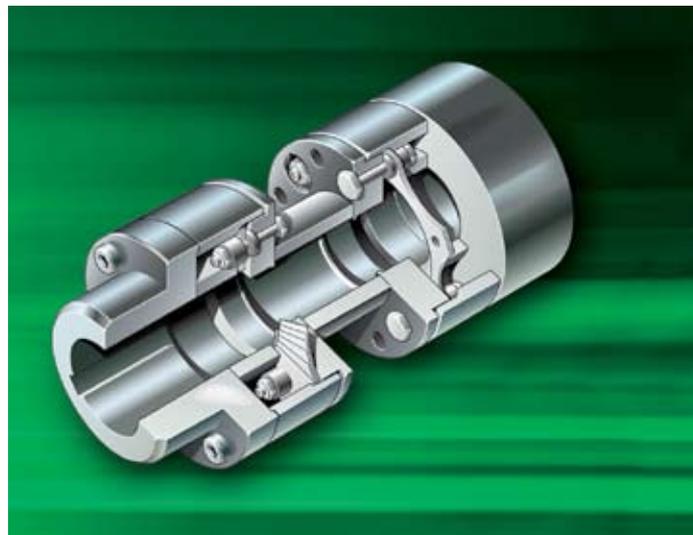
Situated on the 100-acre (40-hectare) site is a two-cell cooling tower that had been a trouble spot for years. Constructed of timber, the 40-ft.-high tower features a pair of 20-ft.-diameter fans mounted on right-angle gearboxes that have a reduction ratio between 5:1 and 6:1. Each fan is powered by a 22 kW (30 hp) variable-speed motor mounted outside the periphery of the fan tips. The motor speed ranges from about 700 rpm to about 1,450 rpm. Each motor is connected to its respective gearbox shaft by a 4.5 m-long (15 ft.), stainless steel coupling. Only 75 mm (3 in.) in diameter, these couplings exhibit a rather large length-to-width ratio, which, combined with the flexibility of the metal, proved to be the source of a worrisome vibration problem.

At both the low- and high-ends of the motor's speed range, coupling vibration was minimal. But as the motors sped up to about 1,200 rpm, the couplings passed through a region of resonance. The coupling began to vibrate severely and, because of the flexibility of the timber structure, the whole cooling tower began to shake.

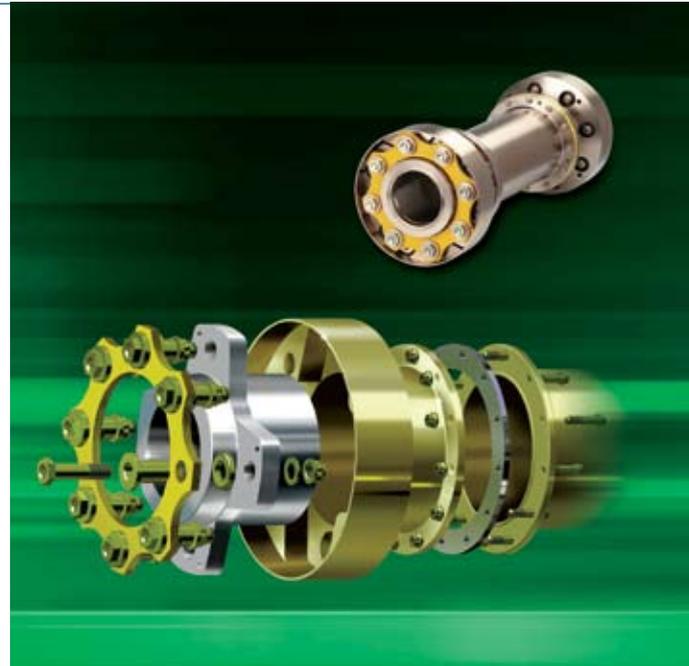
The Autoflex High Speed series CT coupling was selected as the replacement. The unit is a 2,750 mm-long (9 ft.) hollow carbon-fiber composite shaft with stainless steel fittings bonded to the ends. With an outside diameter of only 83 mm (3.25 in.), it weighs less than 12 Kg (26 lbs.). These couplings require no lubrication, which minimizes maintenance. They are direct replacements for existing couplings. This minimizes installation problems and operational risk.

After aligning the motor shaft and gearbox shaft with a laser unit, the coupling ends were fitted with flexible elements that can accommodate as much as 0.25 angular degree of residual misalignment. But

it’s the rigidity of the carbon fiber coupling shaft that makes a difference in the vibration readings. The carbon fiber composite simply doesn’t flex as much as the stainless steel unit flexed.

During the past year, the plant has been monitoring cooling tower drive system vibration, mainly to protect the bearings in the motor and gearbox. “Now, we’re getting a vibration of 2.5 mm/sec., worst case,” says the plant’s rotating equipment engineer. “That is consistent across the motor speed range.”

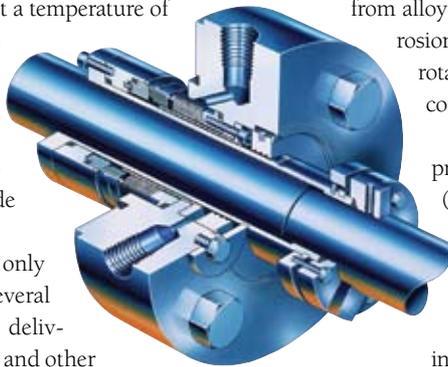
After considering the available options, Petroplus agreed to deviate from policy and try a Flowserve BXRH high-temperature stationary bellows seal. This particular unit features a semi-cartridge design that simplifies installation, graphite gasketing that handles the temperature, a bellows fabricated from alloy 718 to prevent potential corrosion, and Type 316 stainless steel rotating parts. The BXRH seal complies with API 682.

The BXRH seals handle pressures as high as 20 bar (300 psi), temperatures to 427°C (800°F) and surface speeds to 46 m/sec (150 ft/sec). They fit shaft sizes from 25 mm to 101 mm (1 in. to 4 in.). Because the bel-

lows is stationary, the BXRH seal can tolerate higher speeds and some misalignment.

Petroplus installed its first BXRH seal on a bitumen pump in December of 1992. Initially, the seal was the subject of close monitoring, but it exhibited no obvious symptoms of failure. As it continued to operate without incident, its priority ebbed and it was soon off the radar screen. Such was the situation until April, 2007, when the seal flange drain port became blocked. That's when Richards realized that the BXRH seal served more than 15 years without a problem. And, that problem was only a minor one, easily resolved with a simple cleaning.
